Analysis of electroluminescence and infrared thermal images of monocrystalline silicon photovoltaic modules after 20 years of outdoor use in a solar vehicle / Berardone, I.; Paggi, M.; Lopez Garcia, J.. - In: SOLAR ENERGY. - ISSN 0038-092X. - 173:(2018), pp. 478-486. [10.1016/j.solener.2018.07.055]

# Analysis of electroluminescence and infrared thermal images of monocrystalline silicon photovoltaic modules after 20 years of outdoor use in a solar vehicle

I. Berardone<sup>a,1</sup>, J. Lopez Garcia<sup>b</sup>, M. Paggi<sup>a</sup>

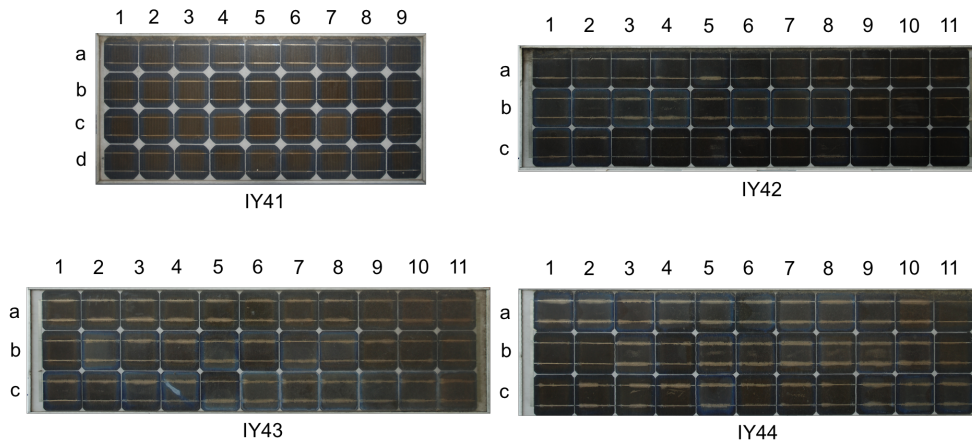
All the modules were not cleaned after installation on the car indeed, visual characterization showed soiling in all modules (Fig. 2). In the images presented in this study, each cell is identified with a code composed by module name, a letter and a number. The letter identifies the row, instead the number identifies the column of each defective cell. The quasi-horizontal mounting configuration caused a uniform distribution of soiling whereas, modules with low tilted angle showed a more pronounced soiling in the lower part of the module, close to the frame. Visual characterization highlighted several types of damage as delamination (close to the cell interconnect ribbons and over the cell, respectively), cracked cells, discoloration of cells, interconnect ribbons and yellowing of the center or whole cells.

Figure 2: Visual characterization of the four modules IY41, IY42, IY43 and IY44.

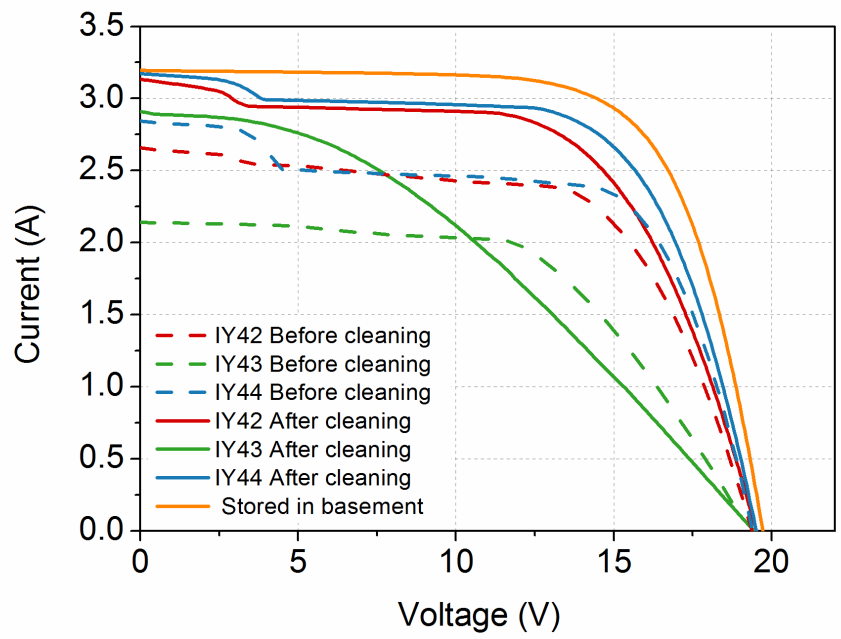
I–V measurements were performed, before and after cleaning, after 20 years of outdoor exposure. Before cleaning, Arcosolar I–V curves present kinks at low voltage, absent in the case of the module stored in the basement taken as reference (orange line), see Fig. 3. This can be attributed to the soiling and to a non-uniform shading. Generally, I–V kinks due to non-uniform shading (i.e. soiling) are reversible and disappear after manual cleaning or major rainfall events (Schill et al., 2011; Dolara et al., 2013; Schill et al., 2015). Otherwise, kinks in modules IY42 and IY44 are still evident after cleaning, and this suggests the presence of additional problem as a higher level of damage.

Figure 3: I-V measurement for IY42, IY43 and IY44 before and after cleaning.

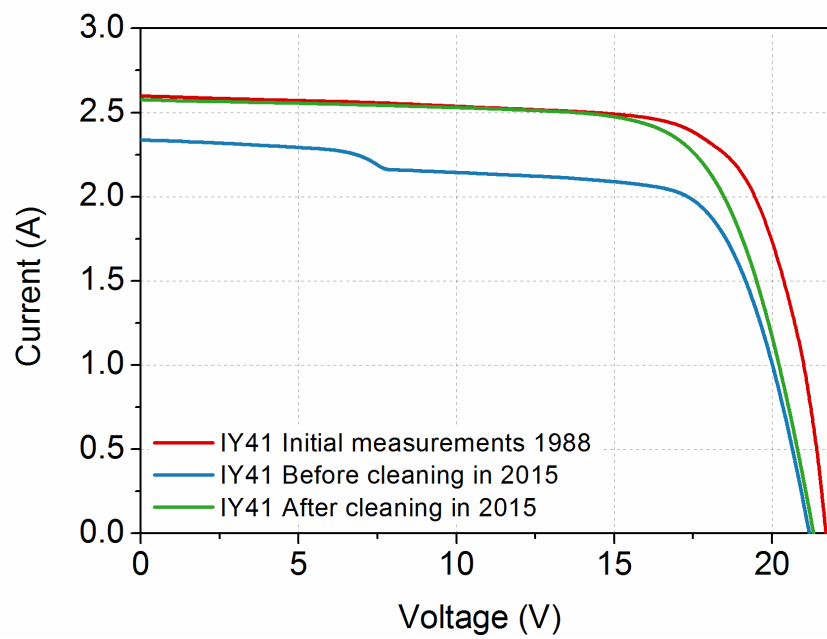
Fig. 4 shows three I–V curves for IY41 module: in 1988 (red line), in 2015 before (blue line) and after cleaning (green line). In this case, the kink at low voltage is present in the blue curve, probably due to soiling, and it disappears after cleaning.

Figure 4: I-V measurement for IY41 before the connection to the car in 1988 (red line) and 2015, before (blue line) and after cleaning (green line).

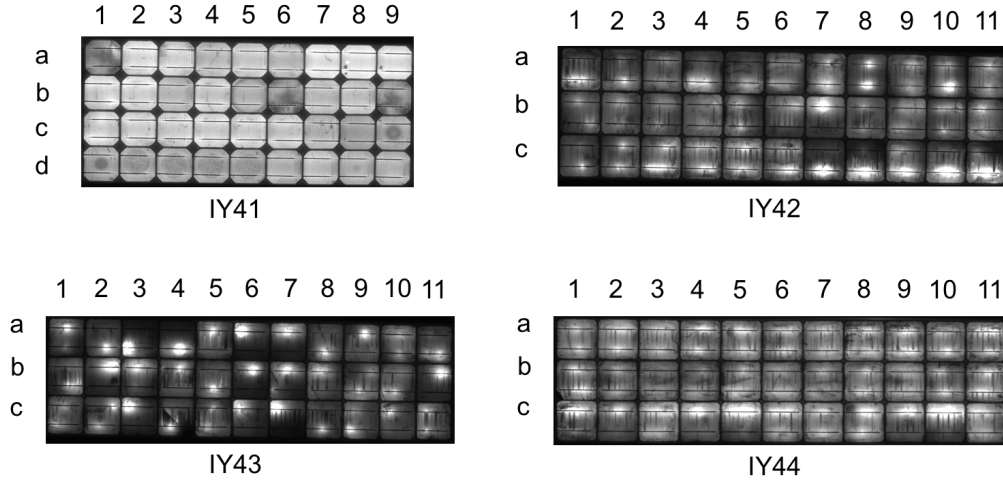
Measurement condition for EL images (see Fig. 5) was the same for all modules, thus resulting EL intensity is related to minority carried diffusion length (Fuyuki et al., 2007). EL image of IY41 presents darker cells in the bottom of the module, close to the soiled edge. Other defects are sucker handling (2d, 3d, 4d, 5d), striation rings (9c, 1d), poor ribbon soldering (1a, 6b, 9b), finger interruption. EL images of IY42 and IY43 show brighter spot close to the busbar or cell interconnect ribbons, and the overall EL intensity is very low. Reasons for brighter spots are contacting problems. The cell

Figure 5: Electroluminescence images of the for modules IY41, IY42, IY43 and IY44.

with the lowest intensity shows a crack, that electrically disconnects a part of the cell (4c in IY43). IY44 has a low EL intensity and the a high numbers of finger interruptions.

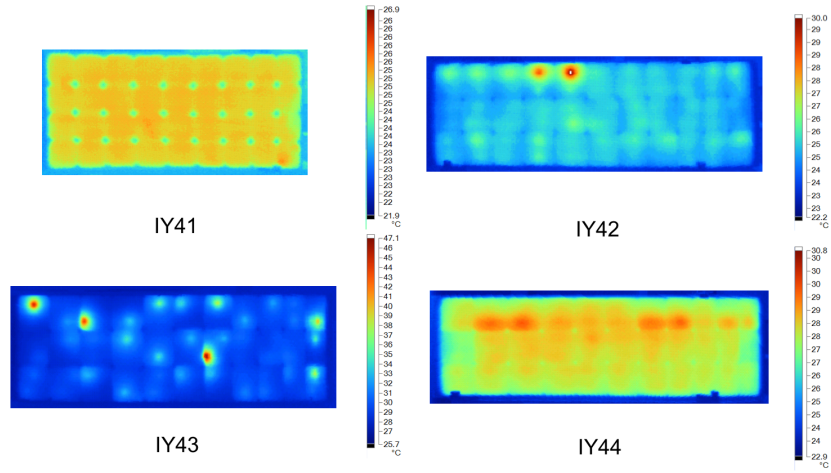
The severity of defects increases from SR to DCL based on the brightness of the EL image of the cells that becomes dimmer and dimmer from SR to DCL. IR images under forward bias condition have spots with higher temperature, as shown in Fig. 7. One is present in module IY41, two in IY42, three hot spot in IY43 and a brighter line in the bottom of IY44, corresponding to higher resistivity along the interconnect ribbons. Illuminated IR images, on the other hand, do not show particular defect point (see Fig. 8).

Figure 7: Dark infrared thermography images for modules IY41, IY42, IY43 and IY44.

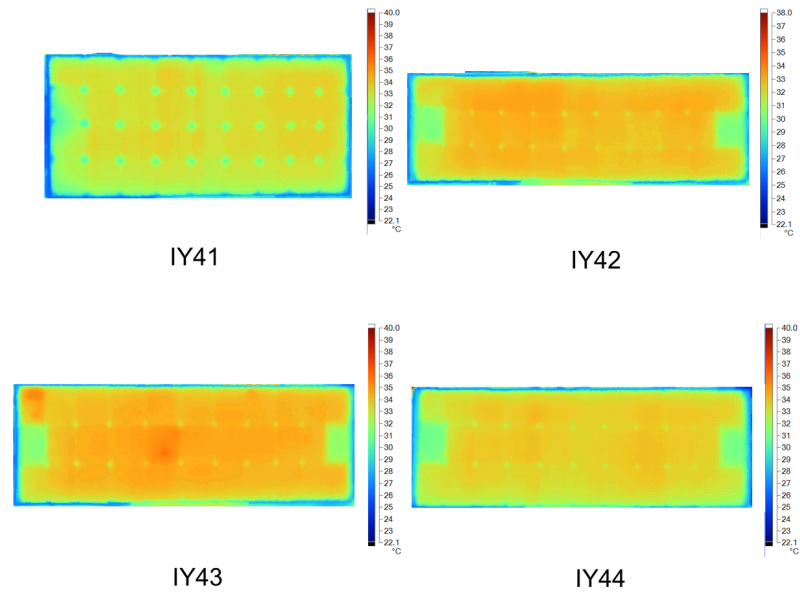
Figure 8: Infrared thermography under illumination for modules IY41, IY42, IY43 and IY44.

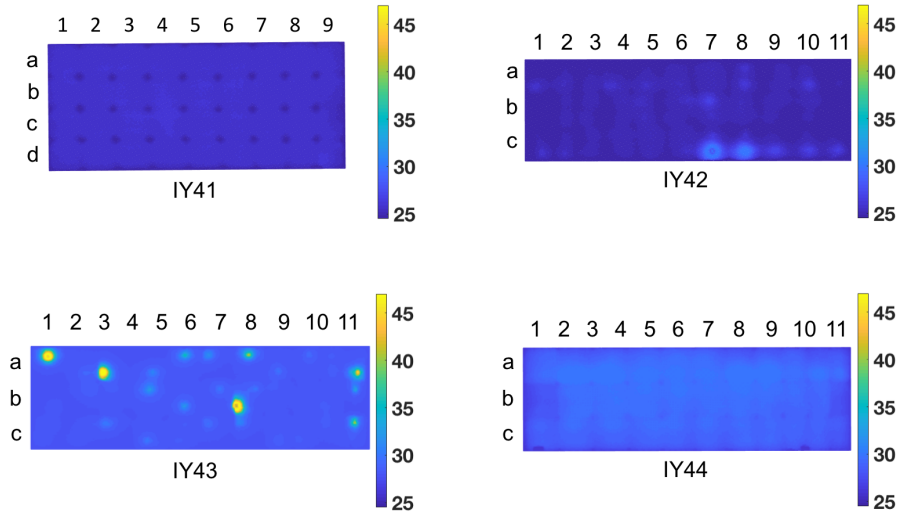
We adopted the method described in Sec.2 to compute the thermal maps starting of the IR images. Thermal maps of IR under forward bias show spots with higher temperature in correspondence of a part of defects visible in the EL images (Fig. 9). On the other hand, thermal maps corresponding to

Figure 9: Thermal maps under dark condition for modules IY41, IY42, IY43 and IY44.

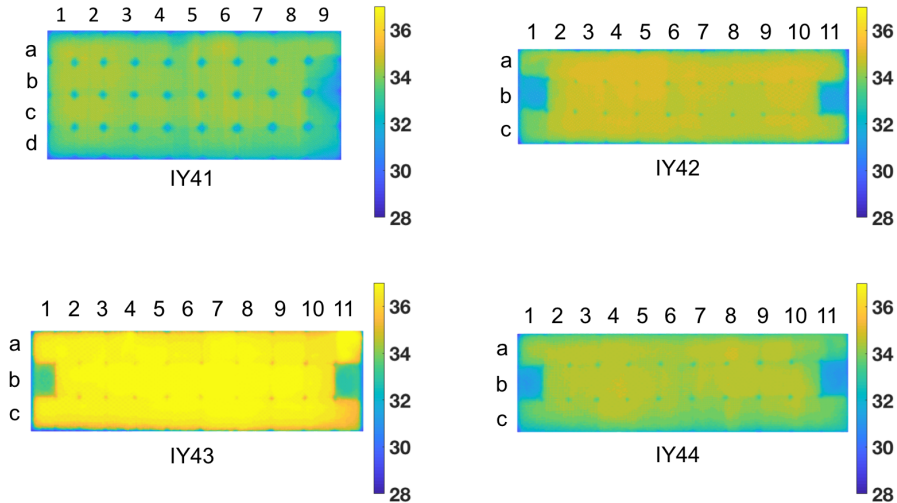
illuminated IR images display a much more uniform temperature distribution and concentrated defects are not detectable by a qualitative analysis (Fig. 10).

Figure 10: Thermal maps under illumination for modules IY41, IY42, IY43 and IY44.
