Nondestructive monitoring of damage caused by accelerated ageing in photovoltaic modules

Irene Berardone¹ and Marco Paggi¹

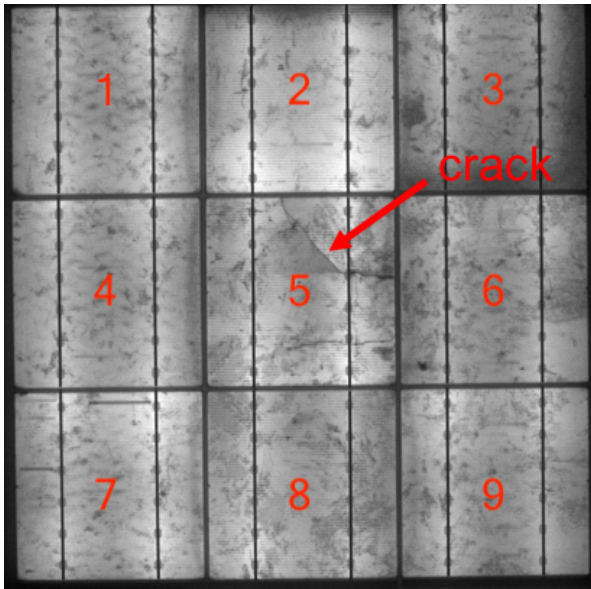
(a) EL image of the PV mini-module after production.

Accelerated ageing is performed in reference to a 9-cell square PV mini-module (50×50 cm), subjected to thermal cycling²⁰. The module was manufactured in the Institute for Solar Energy Research Hamelin (Germany), and laminated without junction box or frames. The module consists of two-busbars 3×3 multi-crystalline silicon solar cells (15.6 cm wide), protected by a 4 mm thick white glass and encapsulated with commercial poly(ethylene-co-vinyl-acetate) (EVA). The backsheet is 0.17 mm thick, and it is composed of three tedlar-based layers. The solar cells are electrically connected in series. The cell in the middle of the module presents one main crack. EL and flash tests have been performed on the module before accelerated ageing. The initial crack clearly visible in the solar cell no. 5 (the central one in Fig. 2(a)) does not lead to electric power losses, since there are no dark zone in the image that would imply electrical insulation.

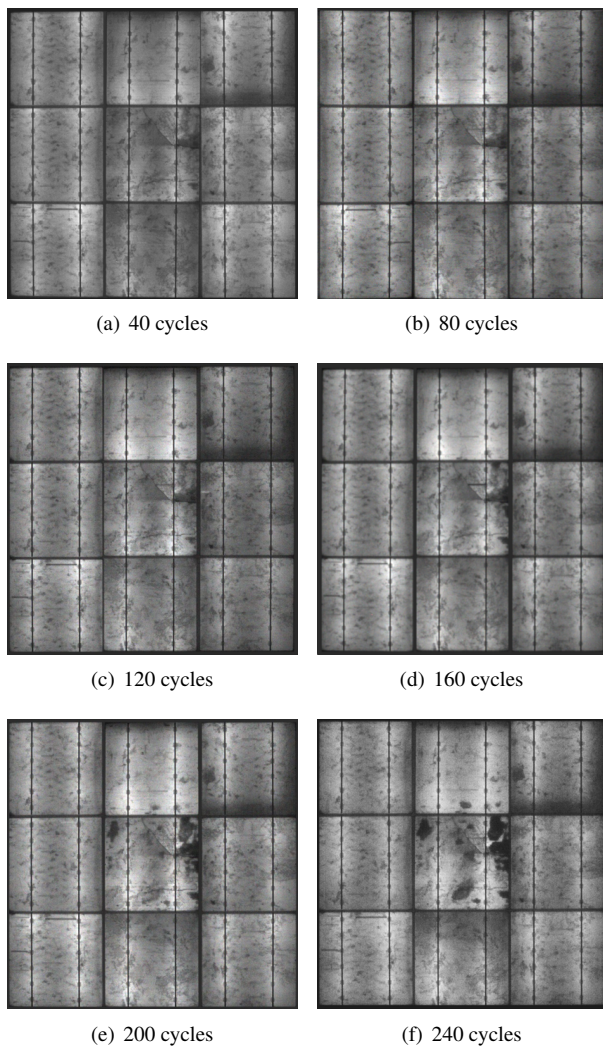
Modified thermal cycling tests to account for a high relative humidity environment led to a progressive shift of the EL signal towards dimmer tones, due to thermo-mechanical stresses (see Figs. 4 and 5). Focusing the attention on the central cell of the module, which contains an initial crack, we note that after 80 cycles, the size of the dimmer area near the crack increases (Fig. 4(b)). This phenomenon can be attributed to thermo-mechanical stresses which accelerate the gridline failure. This degradation is particularly promoted by the presence of cracks, as it can be noted by comparing the EL image of the central cell with the other ones. After 160 cycles (Fig. 4(d)), failure of a finger takes place in the central cell, see the horizontal dark line starting from the busbar. After 200 cycles (Fig. 4(e)) dark spots appear also far from the crack and spread over the testing time. After 200 cycles, the heavily damaged portion of the gridline starts conducting again at cycle no. 280 (Fig. 5(a)), suggesting its progressive failure and disconnection. Eventually, the complete electrical disconnection of the area comprised between the crack and the busbar takes place in correspondence of 400 cycles (Fig.

Figure 4. Electroluminescence images during accelerating ageing after: (a) 40 cycles; (b) 80 cycles; (c) 120 cycles; (d) 160 cycles; (e) 200 cycles; (f) 240 cycles.

5(d)). This severe form of damage and its kinetics are not observed in the other solar cells that had no initial cracks.

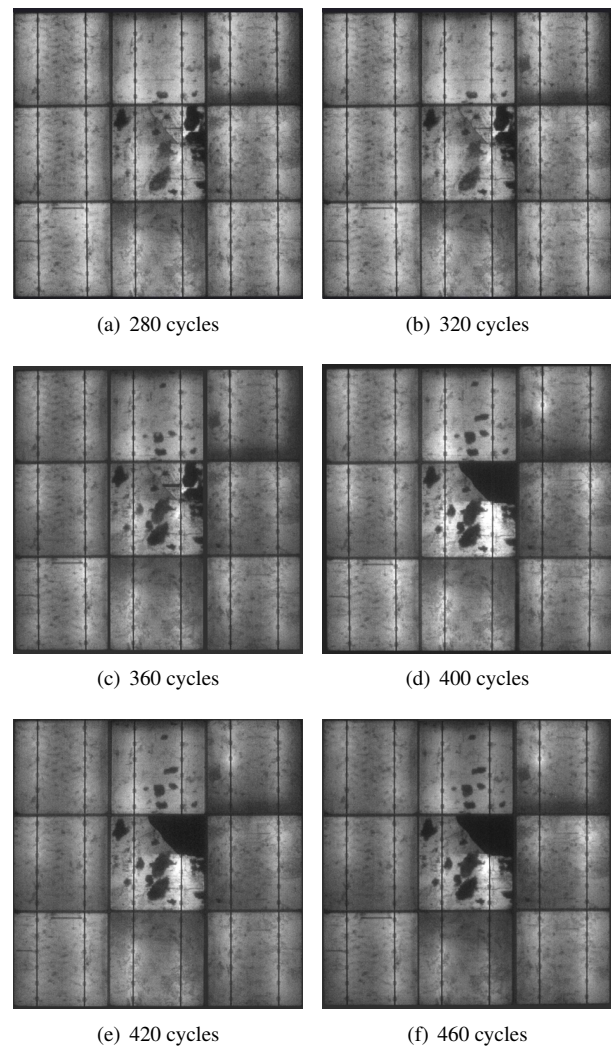
Figure 5. Electroluminescence images during accelerating ageing after: (a) 280 cycles; (b) 320 cycles; (c) 360 cycles; (d) 400 cycles; (e) 420 cycles; (f) 460 cycles.

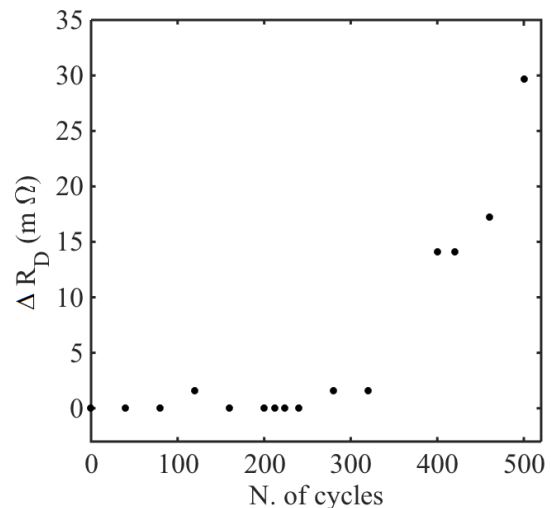
R_D over cycles, especially after 300 cycles (Fig. 8), which corresponds to 1200 h of testing. Thermal cycling tests are

Figure 8. Evolution of the degradation of the electric resistance over time.

usually limited up to 200 cycles, and therefore these results strongly suggest increasing the number of thermal cycles up to 400 cycles to gain a more comprehensive understanding of degradation phenomena.

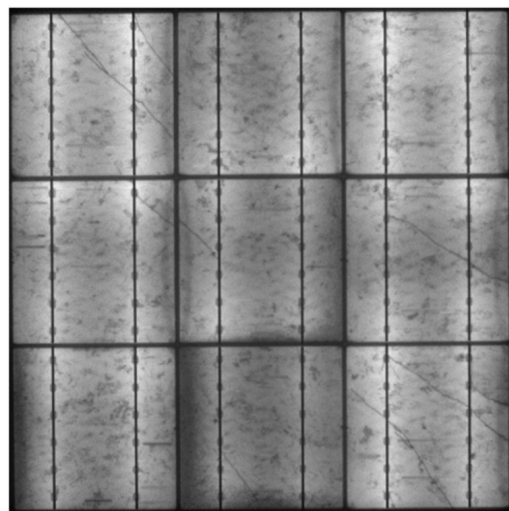
For comparison purposes, another mini-module with similar characteristics has been tested according to the damp-heat standard test sequence. Even in the presence of cracks as in the other mini-module, the EL image after 1000 hours of damp-heat exposure is bright (see Fig.9), with a modest overall reduction of 0.84% in efficiency and of 0.92% in maximum power output P_{MPP} . The slight reduction of the power output seen in the test is consistent by results in ³⁴⁻³⁷. Indeed, high darkening reported in ³⁴ appeared only after 2800 hours of testing. In that case, moisture induced corrosion of the doped oxide that provides the electrical

contact to the emitter of the Silicon cell. Therefore, this comparison reasonably confirms that humidity alone is not able to induce the fast degradation process observed near cracks when also thermal cycling is considered.

Figure 9. EL image of a mini-module after 1000 h of damp-heat.
