# Nondestructive monitoring of damage caused by accelerated ageing in photovoltaic modules

Irene Berardone<sup>1</sup> and Marco Paggi<sup>1</sup>

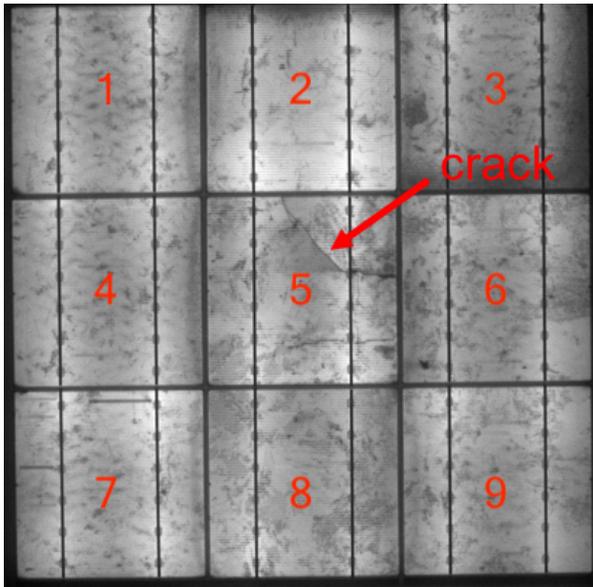
(a) EL image of the PV mini-module after production.

Accelerated ageing is performed in reference to a 9-cell square PV mini-module ( $50 \times 50$  cm), subjected to thermal cycling<sup>20</sup>. The module was manufactured in the Institute for Solar Energy Research Hamelin (Germany), and laminated without junction box or frames. The module consists of two-busbars  $3 \times 3$  multi-crystalline silicon solar cells (15.6 cm wide), protected by a 4 mm thick white glass and encapsulated with commercial poly(ethylene-co-vinyl-acetate) (EVA). The backsheet is 0.17 mm thick, and it is composed of three tedlar-based layers. The solar cells are electrically connected in series. The cell in the middle of the module presents one main crack. EL and flash tests have been performed on the module before accelerated ageing. The initial crack clearly visible in the solar cell no. 5 (the central one in Fig. 2(a)) does not lead to electric power losses, since there are no dark zone in the image that would imply electrical insulation.

**Figure 2.** EL image of mini-module as received (a), and photo of the PV module inside the climatic chamber (b).

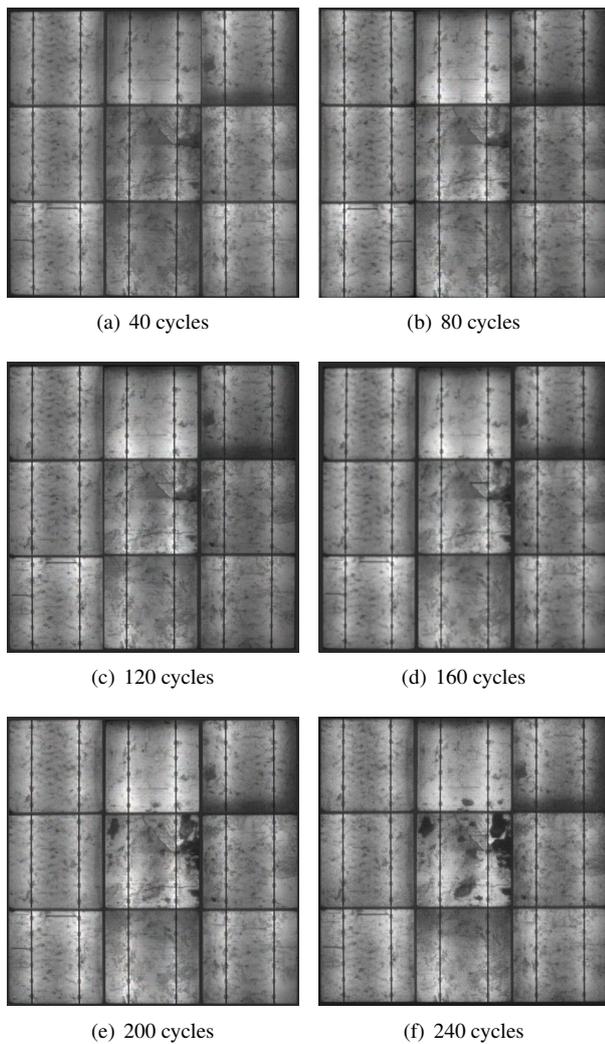
Modified thermal cycling tests to account for a high relative humidity environment led to a progressive shift of the EL signal towards dimmer tones, due to thermo-mechanical stresses (see Figs. 4 and 5). Focusing the attention on the central cell of the module, which contains an initial crack, we note that after 80 cycles, the size of the dimmer area near the crack increases (Fig. 4(b)). This phenomenon can be attributed to thermo-mechanical stresses which accelerate the gridline failure. This degradation is particularly promoted by the presence of cracks, as it can be noted by comparing the EL image of the central cell with the other ones. After 160 cycles (Fig. 4(d)), failure of a finger takes place in the central cell, see the horizontal dark line starting from the busbar. After 200 cycles (Fig. 4(e)) dark spots appear also far from the crack and spread over the testing time. After 200 cycles, the heavily damaged portion of the gridline starts conducting again at cycle no. 280 (Fig. 5(a)), suggesting its progressive failure and disconnection. Eventually, the complete electrical disconnection of the area comprised between the crack and the busbar takes place in correspondence of 400 cycles (Fig.

**Figure 4.** Electroluminescence images during accelerating ageing after: (a) 40 cycles; (b) 80 cycles; (c) 120 cycles; (d) 160 cycles; (e) 200 cycles; (f) 240 cycles.

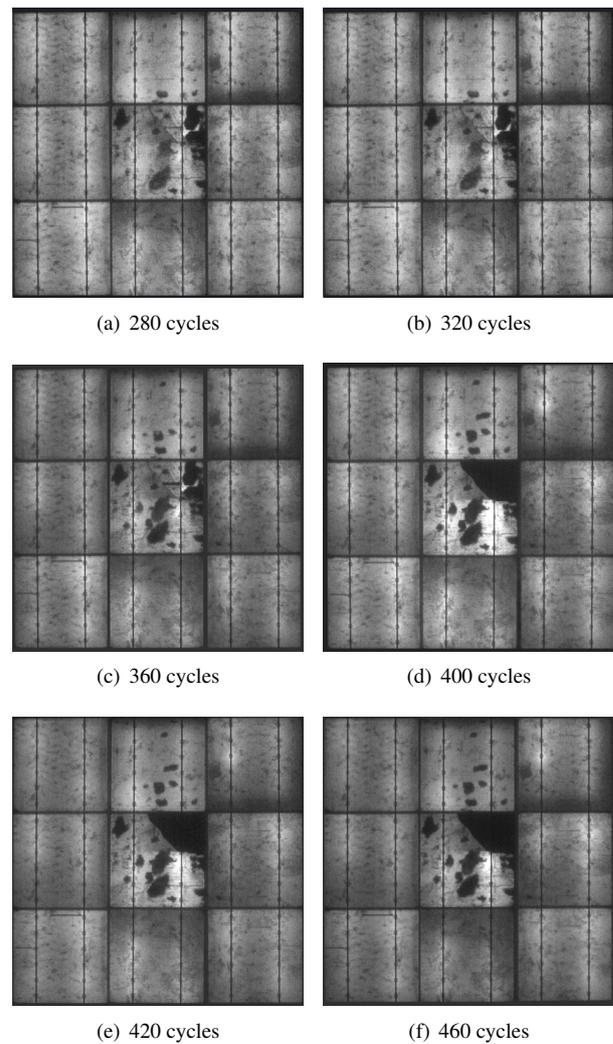
**Figure 5.** Electroluminescence images during accelerating ageing after: (a) 280 cycles; (b) 320 cycles; (c) 360 cycles; (d) 400 cycles; (e) 420 cycles; (f) 460 cycles.

5(d)). This severe form of damage and its kinetics are not observed in the other solar cells that had no initial cracks.

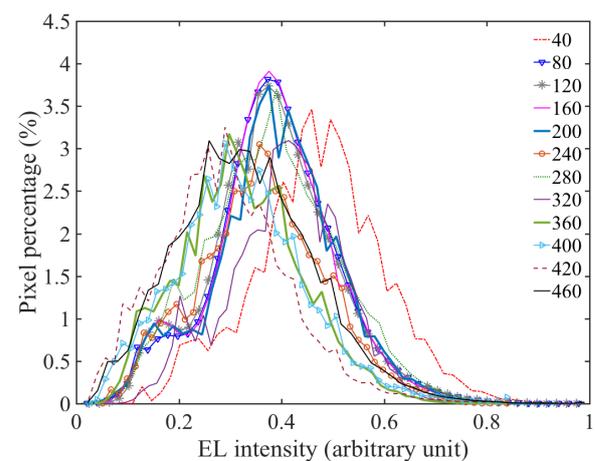
The shift of the EL signal towards dimmer tones is quantified in the histograms of the EL signal (Fig. 6). Such histograms for the whole mini-module are almost symmetric and a shift towards lower EL intensities is noticed with the progress of the test (Fig. 6). Focusing on some representative solar cells, the evolution of the EL histograms for the central cracked cell is shown in Fig. 7(a) and it is quite different from that of solar cells without cracks (see Fig. 7(b) for the solar cell no. 4). The presence of cracking accelerates the shift of the EL intensities towards dimmer tones, i.e., towards low EL intensities.

**Figure 6.** Histograms of the EL intensities after 40, 80, 120, 160, 200, 240, 280, 320, 360, 400, 420 and 460 cycles for the whole mini-module.

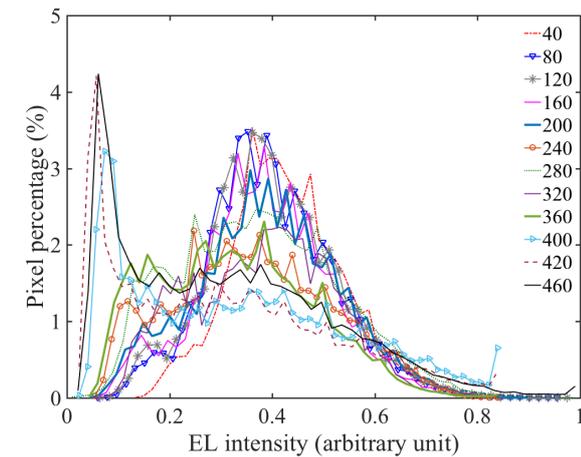
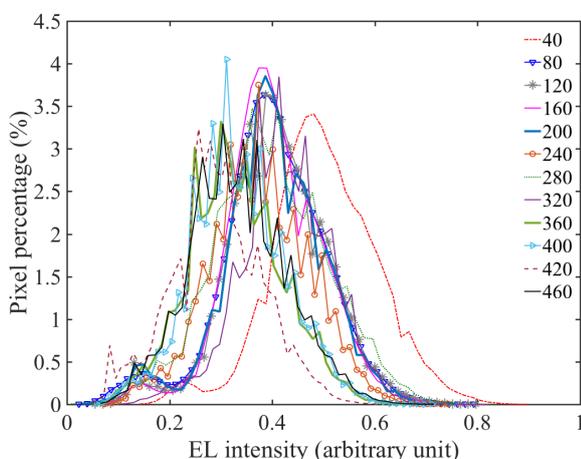
**Figure 7.** Histograms of the EL intensities after 40, 80, 120, 160, 200, 240, 280, 320, 360, 400, 420 and 460 cycles for the central cell (cell no. 5) (a), and for a lateral one (cell no.4) (b).

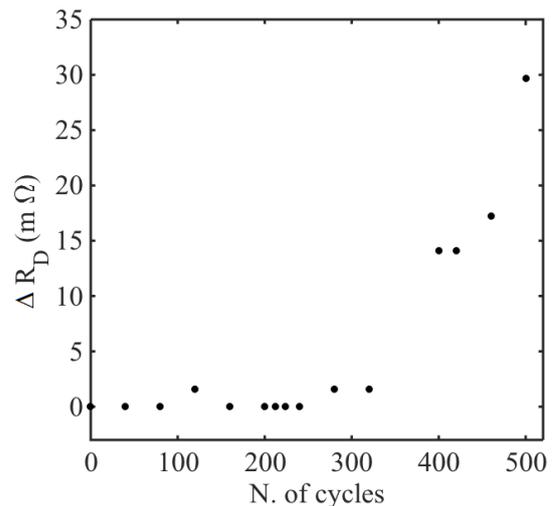
$R_D$  over cycles, especially after 300 cycles (Fig. 8), which corresponds to 1200 h of testing. Thermal cycling tests are

**Figure 8.** Evolution of the degradation of the electric resistance over time.

usually limited up to 200 cycles, and therefore these results strongly suggest increasing the number of thermal cycles up to 400 cycles to gain a more comprehensive understanding of degradation phenomena.

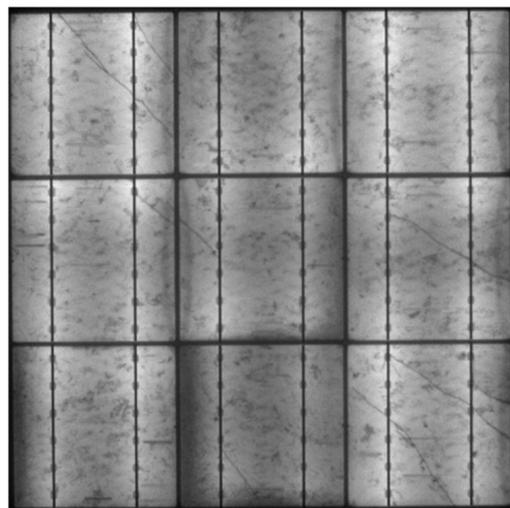
For comparison purposes, another mini-module with similar characteristics has been tested according to the damp-heat standard test sequence. Even in the presence of cracks as in the other mini-module, the EL image after 1000 hours of damp-heat exposure is bright (see Fig.9), with a modest overall reduction of 0.84% in efficiency and of 0.92% in maximum power output  $P_{MPP}$ . The slight reduction of the power output seen in the test is consistent by results in <sup>34-37</sup>. Indeed, high darkening reported in <sup>34</sup> appeared only after 2800 hours of testing. In that case, moisture induced corrosion of the doped oxide that provides the electrical

contact to the emitter of the Silicon cell. Therefore, this comparison reasonably confirms that humidity alone is not able to induce the fast degradation process observed near cracks when also thermal cycling is considered.

**Figure 9.** EL image of a mini-module after 1000 h of damp-heat.
