Analysis of electroluminescence and infrared thermal images of monocrystalline silicon photovoltaic modules after 20 years of outdoor use in a solar vehicle

I. Berardone^{a,1}, J. Lopez Garcia^b, M. Paggi^a

^a*IMT School for Advanced Studies Lucca, Piazza San Francesco 19, 55100 Lucca, Italy*
^b*European Commission, DG JRC, Directorate C-Energy, Transport and Climate, Energy efficiency and Renewables Unit, Via E. Fermi 2749, 21027 Ispra (VA), Italy*

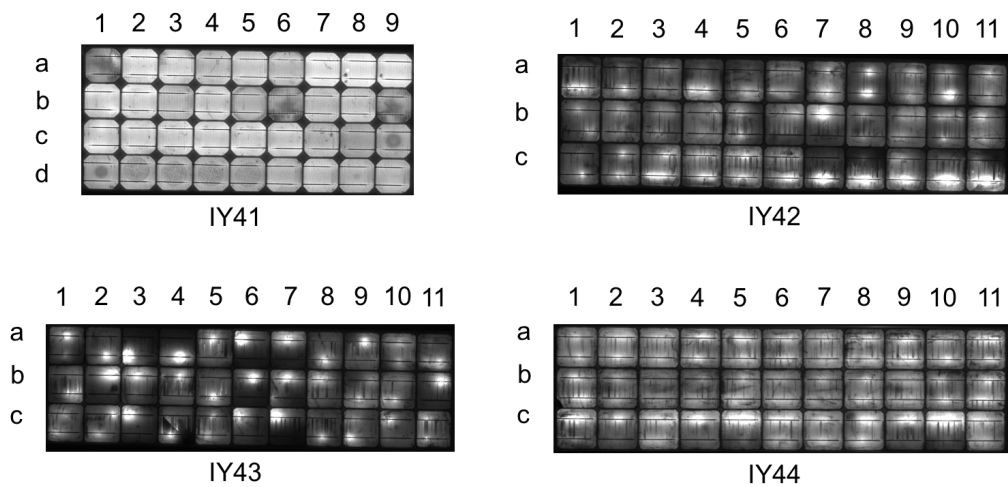
Measurement condition for EL images (see Fig. 5) was the same for all modules, thus resulting EL intensity is related to minority carried diffusion length (Fuyuki et al., 2007). EL image of IY41 presents darker cells in the bottom of the module, close to the soiled edge. Other defects are sucker handling (2d, 3d, 4d, 5d), striation rings (9c, 1d), poor ribbon soldering (1a, 6b, 9b), finger interruption. EL images of IY42 and IY43 show brighter spot close to the busbar or cell interconnect ribbons, and the overall EL intensity is very low. Reasons for brighter spots are contacting problems. The cell

Figure 5: Electroluminescence images of the for modules IY41, IY42, IY43 and IY44.

with the lowest intensity shows a crack, that electrically disconnects a part of the cell (4c in IY43). IY44 has a low EL intensity and the a high numbers of finger interruptions.
