Analysis of electroluminescence and infrared thermal images of monocrystalline silicon photovoltaic modules after 20 years of outdoor use in a solar vehicle / Berardone, I.; Paggi, M.; Lopez Garcia, J.. - In: SOLAR ENERGY. - ISSN 0038-092X. - 173:(2018), pp. 478-486. [10.1016/j.solener.2018.07.055]

# Analysis of electroluminescence and infrared thermal images of monocrystalline silicon photovoltaic modules after 20 years of outdoor use in a solar vehicle

I. Berardone<sup>a,1</sup>, J. Lopez Garcia<sup>b</sup>, M. Paggi<sup>a</sup>

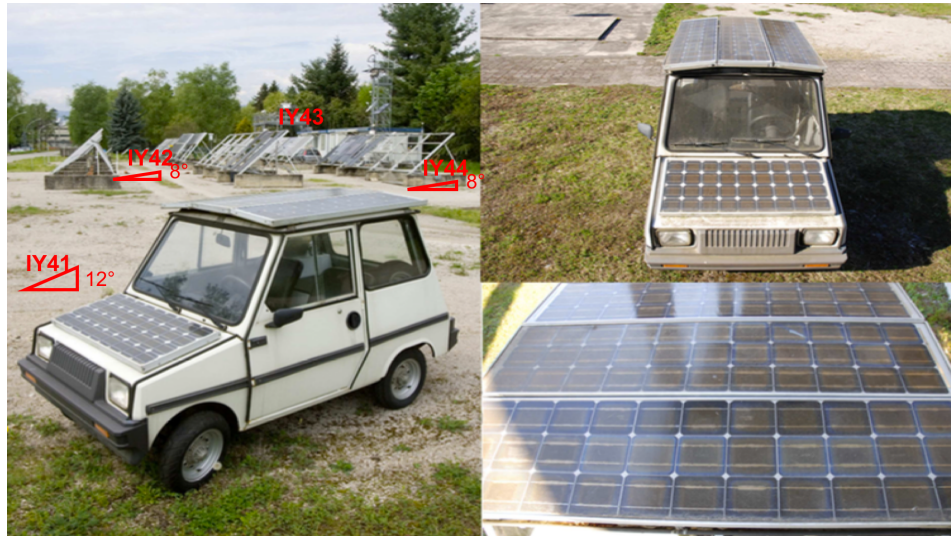
Figure 1: Mazzieri solar car and modules disposition on it.

Three modules (IY42, IY43, IY44) were placed on the roof and the one on the bonnet (IY41) of the car. They were connected to a battery. The disposition of module on the solar car was the following: module IY41 had a tilt angle of  $12^\circ$ , IY42 and IY44 of  $8^\circ$ , while IY43 was installed horizontally on the roof (see Fig. 1).

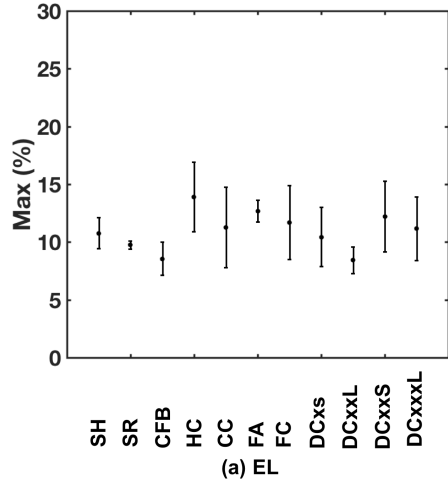
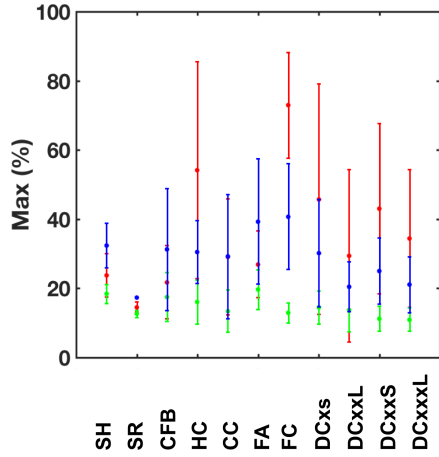
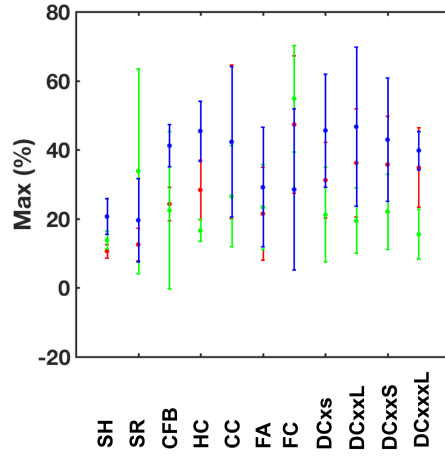
Starting from the histograms, computed for each cell, we have evaluated the the behavior of the average value of maximum peak in the histograms for each defect class. Fig. 11 shows the average of the maximum (%) of histograms for EL (a), IR under biased condition (b) and illuminated condition (c) per each defect class. A slight overlap in red, green and blue channels is observable both in biased and illuminated condition. The maximum peak of green channel has a lower value respect to red and blue one for forward biased condition, but the same trends is not visible under illuminated condition. The maximum peak of EL signal floats around 10% and, considering the error bar, is not possible to denote a general trend related to the defects classes from the analysis of maximum.

Figure 11: Average value of the absolute peak of the histogram of EL and IR signal per each defect class.

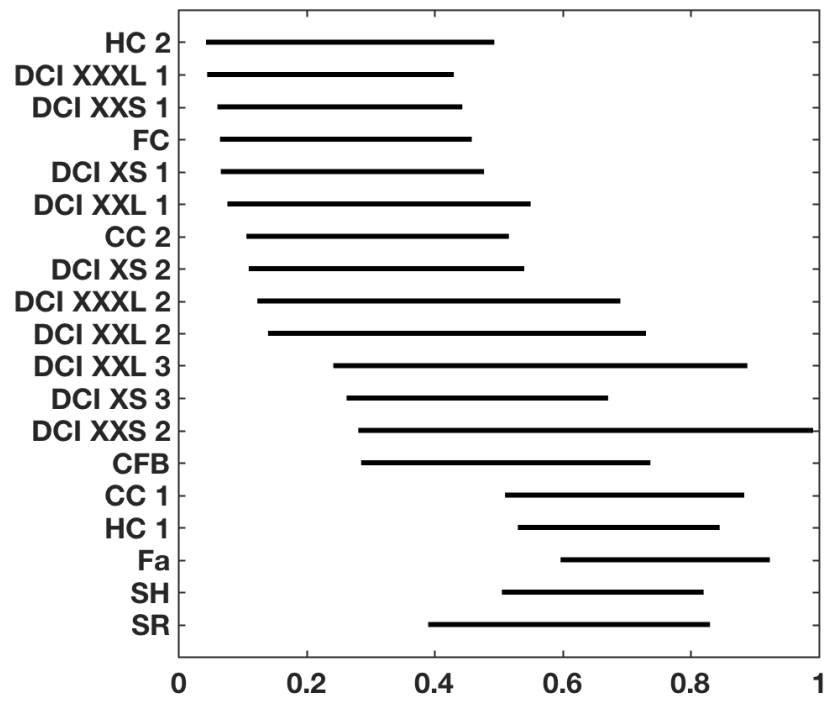
defect class. Such a range depends both on the defect class and on module condition. The analysis of the EL signal shows an increasing trend in the range of intensities by moving from HC 2 up to SR (Fig. 12). Visual inspection seems to be required for a careful discrimination among different defect classes because of frequent overlapping between the intervals corresponding to different defect classes. We applied this approach to IR histograms under biased and illuminated condition.

Figure 12: X-range of intensities histogram for EL signal for the different classes of defects in Fig.6.

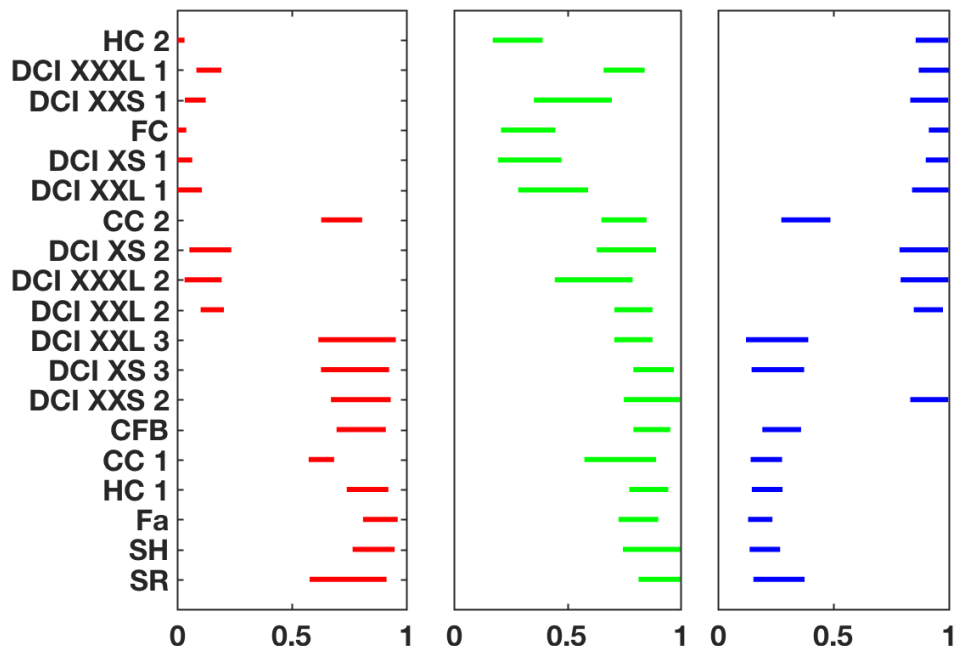
For IR images under forward bias condition, the red and blue channels have an abrupt and opposite change in the ranges from the class DCI XXL 2 onwards. For defect classes from HC 2 up to DCI XXL 2, the range is in the interval between zero and 0.23. From DCI XXL 3 to the SR classes, on the other hand, the interval shifts in the range from 0.78 and unity. The opposite trend is observed for the blue channel, while the green channel has a trend similar to the red one, but without a sharp shift. Only the CC class (CC 1 for the red channel and CC 2 for the red and the blue channels) does not fulfill the observed trend, which can be motivated by the fact that the detected

cross cracks are sources of minor defects for the examined cells. From the physical point of view, these results imply that it is possible to distinguish disconnected cell interconnect (DCI), humidity corrosion (HC) and finger interruption (FC) in highly damaged solar cells. The same analysis repeated

Figure 13: X-range of intensities histogram for red, green and blue channels of the IR signal under forward bias condition, for the different classes of defects in Fig. 6.

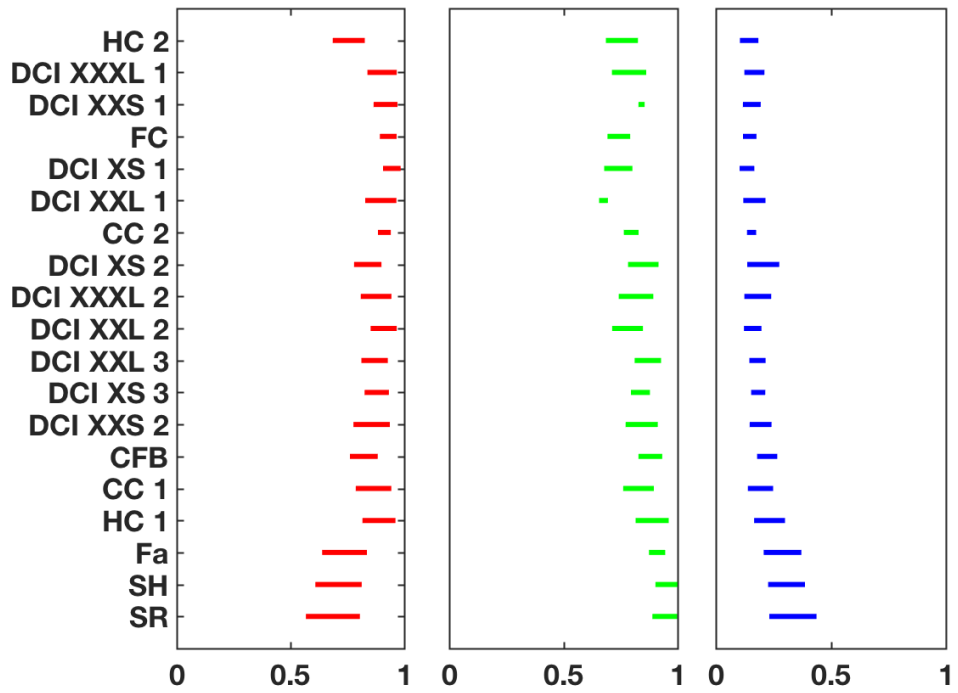
for the histograms of the IR images taken under illumination (Fig. 14) do not show any shift in the interval ranges, thus making nearly impossible to distinguish between the different classes of defects.

Figure 14: X-range of intensities histogram for red, green and blue channels of the IR signal under forward bias condition, for the different classes of defects in Fig. 6.
