Nondestructive monitoring of damage caused by accelerated ageing in photovoltaic modules

Irene Berardone¹ and Marco Paggi¹

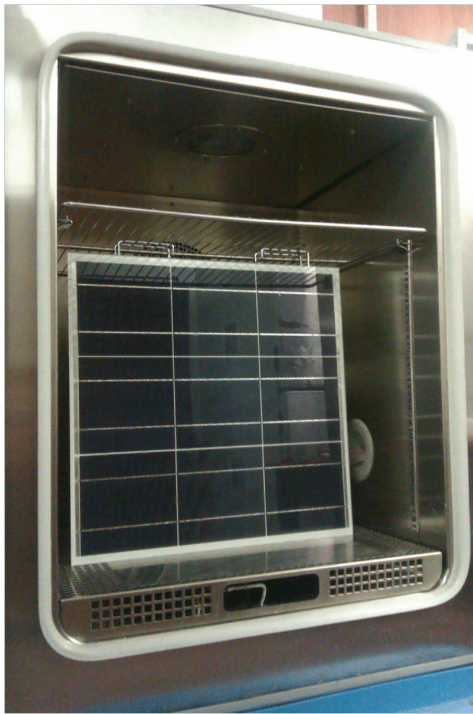
(b) PV mini-module inside the climatic chamber

Figure 2. EL image of mini-module as received (a), and photo of the PV module inside the climatic chamber (b).

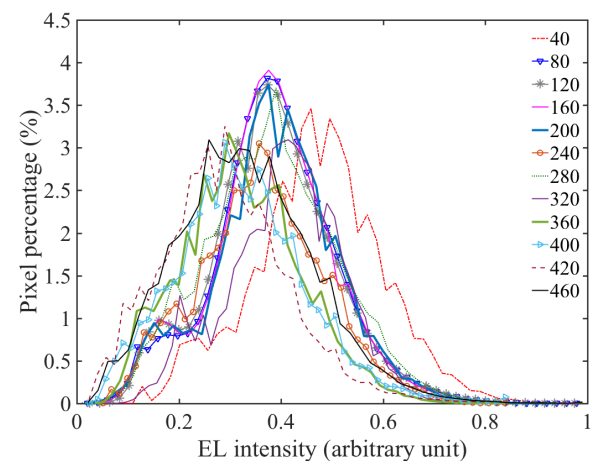
Figure 6. Histograms of the EL intensities after 40, 80, 120, 160, 200, 240, 280, 320, 360, 400, 420 and 460 cycles for the whole mini-module.

The shift of the EL signal towards dimmer tones is quantified in the histograms of the EL signal (Fig. 6). Such histograms for the whole mini-module are almost symmetric and a shift towards lower EL intensities is noticed with the progress of the test (Fig. 6). Focusing on some representative solar cells, the evolution of the EL histograms for the central cracked cell is shown in Fig. 7(a) and it is quite different from that of solar cells without cracks (see Fig. 7(b) for the solar cell no. 4). The presence of cracking accelerates the shift of the EL intensities towards dimmer tones, i.e., towards low EL intensities.

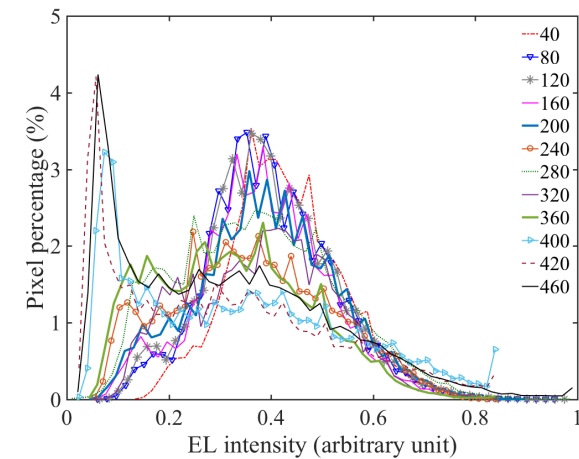
(a) Central cell

Figure 7. Histograms of the EL intensities after 40, 80, 120, 160, 200, 240, 280, 320, 360, 400, 420 and 460 cycles for the central cell (cell no. 5) (a), and for a lateral one (cell no.4) (b).
