# Nondestructive monitoring of damage caused by accelerated ageing in photovoltaic modules

Irene Berardone<sup>1</sup> and Marco Paggi<sup>1</sup>

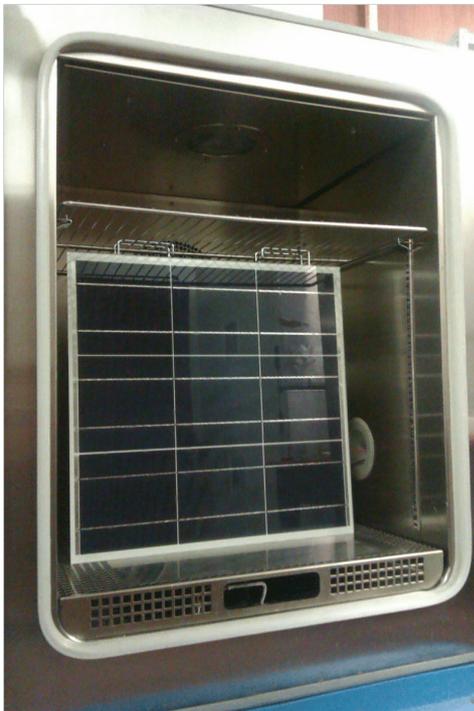
(b) PV mini-module inside the climatic chamber

**Figure 2.** EL image of mini-module as received (a), and photo of the PV module inside the climatic chamber (b).
