Analysis of electroluminescence and infrared thermal images of monocrystalline silicon photovoltaic modules after 20 years of outdoor use in a solar vehicle

I. Berardone^{a,1}, J. Lopez Garcia^b, M. Paggi^a

^a*IMT School for Advanced Studies Lucca, Piazza San Francesco 19, 55100 Lucca, Italy*
^b*European Commission, DG JRC, Directorate C-Energy, Transport and Climate, Energy efficiency and Renewables Unit, Via E. Fermi 2749, 21027 Ispra (VA), Italy*

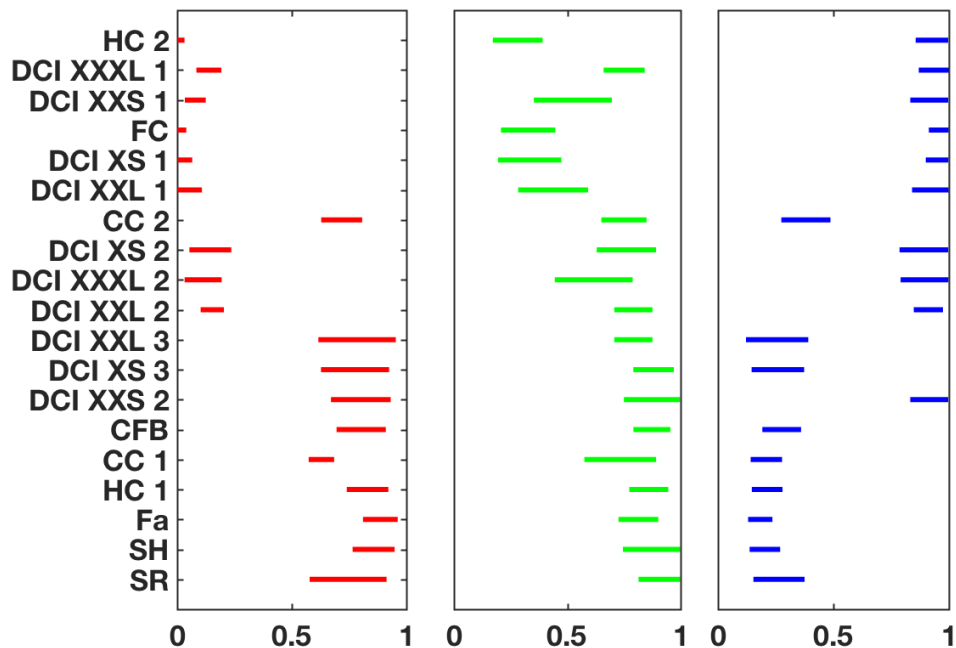
Figure 13: X-range of intensities histogram for red, green and blue channels of the IR signal under forward bias condition, for the different classes of defects in Fig. 6.

For IR images under forward bias condition, the red and blue channels have an abrupt and opposite change in the ranges from the class DCI XXL 2 onwards. For defect classes from HC 2 up to DCI XXL 2, the range is in the interval between zero and 0.23. From DCI XXL 3 to the SR classes, on the other hand, the interval shifts in the range from 0.78 and unity. The opposite trend is observed for the blue channel, while the green channel has a trend similar to the red one, but without a sharp shift. Only the CC class (CC 1 for the red channel and CC 2 for the red and the blue channels) does not fulfill the observed trend, which can be motivated by the fact that the detected

cross cracks are sources of minor defects for the examined cells. From the physical point of view, these results imply that it is possible to distinguish disconnected cell interconnect (DCI), humidity corrosion (HC) and finger interruption (FC) in highly damaged solar cells. The same analysis repeated
